Wrist Trauma

Case Study | CARESTREAM OnSight 3D Extremity System

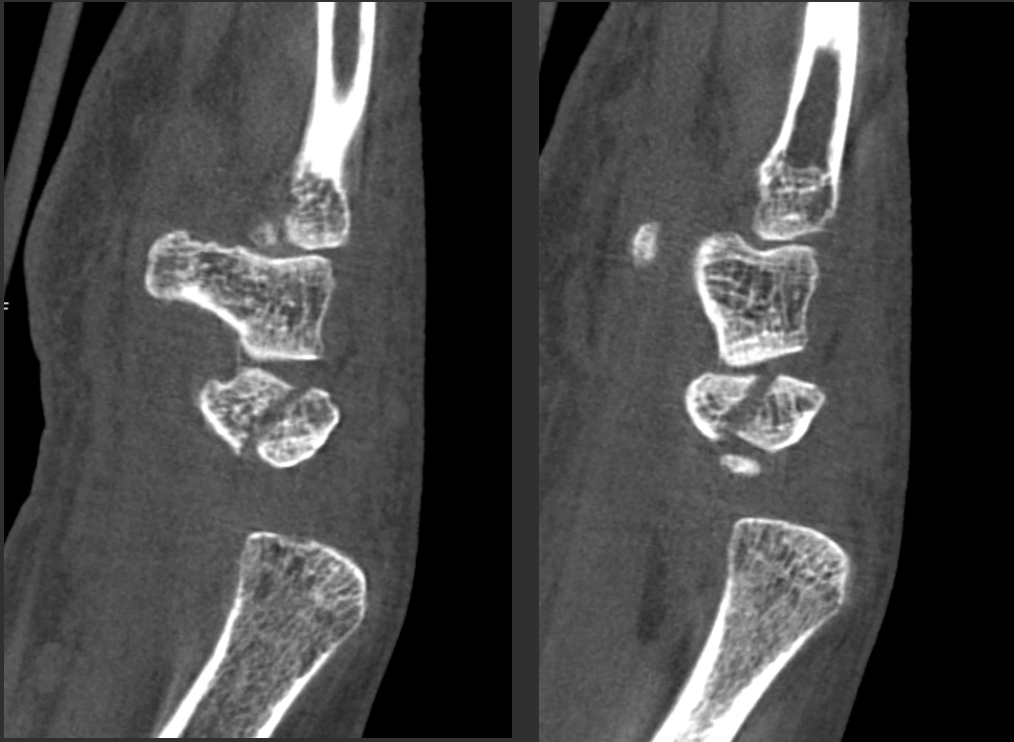
Figure 2 MPR slices from the patient in Figure 1 acquired with the OnSight extremity CT system identifying a clear fracture of the triquetrum not seen in Figure 1.

Figures 2 and 3 show various MPR slices from a 3D scan of the patient taken on the OnSight extremity CT, clearly indicating a large fracture of the triquetrum.
