Foot Trauma

Case Study | CARESTREAM OnSight 3D Extremity System

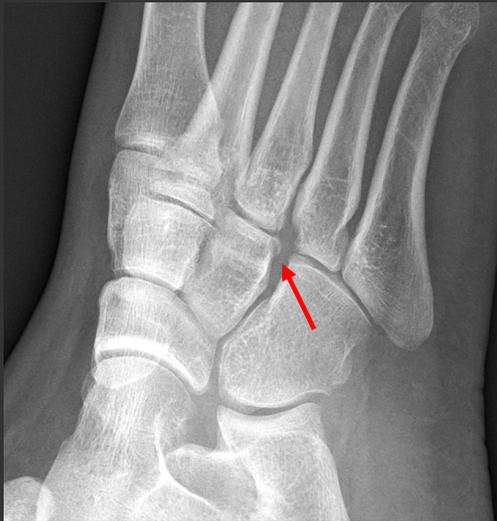
Figure 1 Standard 2D X-ray of foot trauma patient showing small fractures on the lateral side of the lateral cuneiform and the lateral aspect of the proximal epiphysis of the third metatarsal, indicative of a possible Lisfranc injury.

The traditional 2D projection X-rays (see Figure 1) shows evidence of a small fracture on the lateral side of the lateral cuneiform bone and the lateral aspect of the proximal epiphysis of the third metatarsal. This presentation is indicative of a Lisfranc injury and there is a need for a precise lesion assessment to uncover additional injuries and ensure proper treatment for the patient. Failure to identify all aspects of this type of injury can have significant negative impact on the prognosis for full recovery. Historically, 2D imaging is known to miss a significant number of aspects of Lisfranc injury, with clinicians relying heavily on identifying pain during physical exam as a final arbiter of the full scope of the injury.

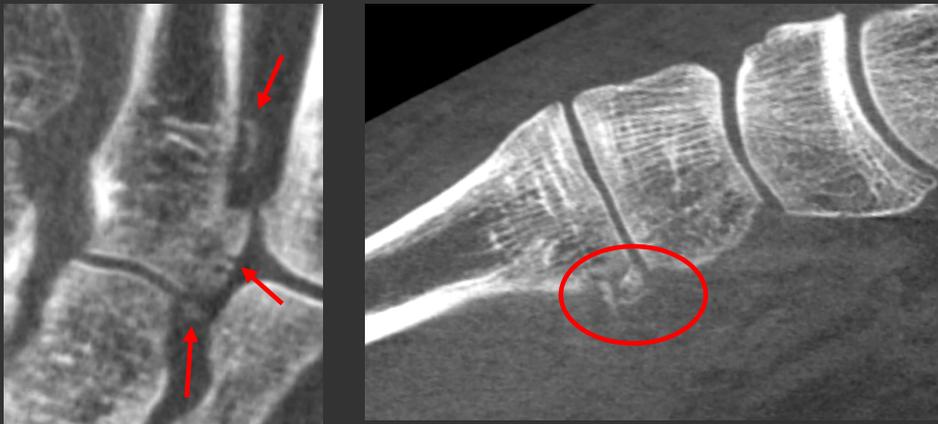
Figure 2 MPR slices from the patient acquired with the OnSight extremity CT system identifying multiple fractures of the base of the second metatarsal not seen in Figure 1.

Imaging with the CARESTREAM OnSight 3D Extremity System showed a number of further injuries. Figure 2 shows multiple fractures of the base of the second metatarsal:

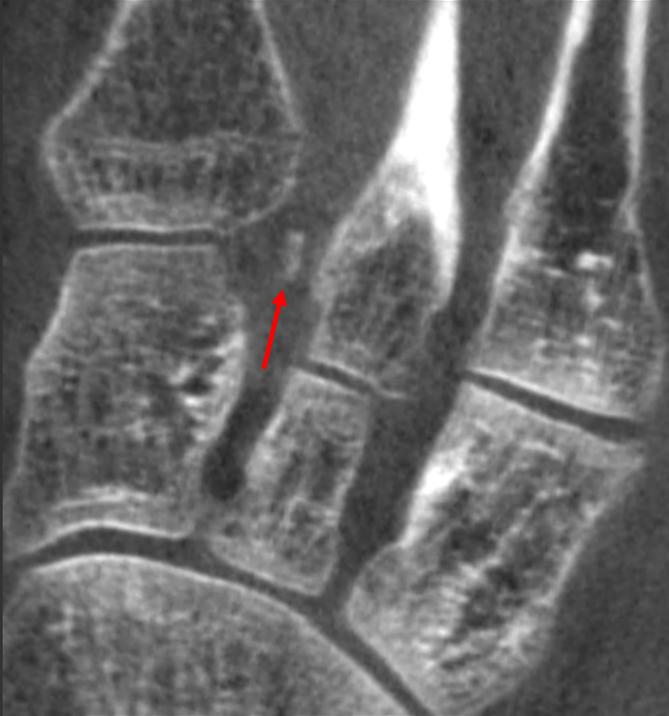
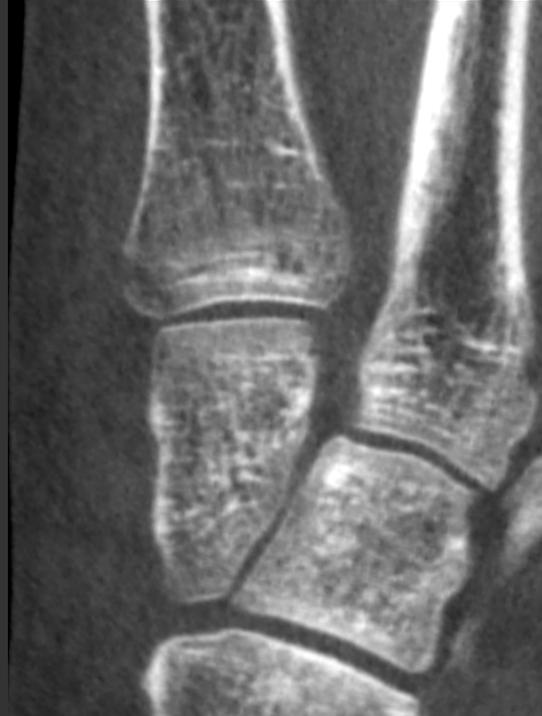
Figure 3 shows evidence of another evulsion fracture of the lateral side of the medial cuneiform bone as well as a fracture of the base of the first metatarsal bone, both unappreciated in Figure 1:

These additional injuries are important to identify and indicate that this patient will require a cast for a significant length of time.
