# CARESTREAM OnSight 3D Extremity System Clinical Case Studies

# Wrist-Hand Trauma

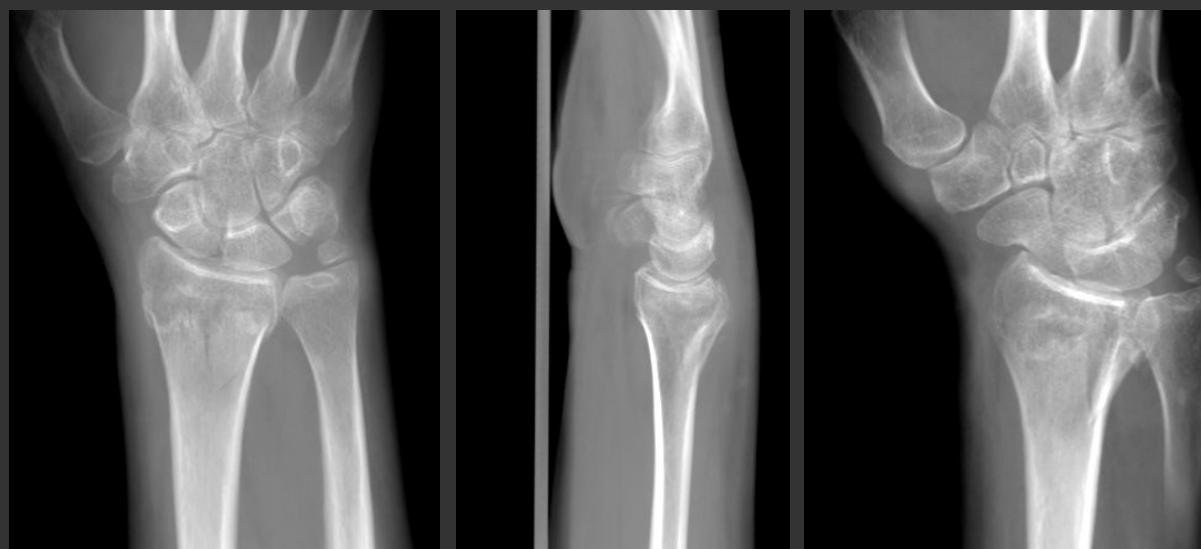
Figure 1 Standard 3-view 2D X-ray with evidence of Colles' fracture (Distal Radius Fracture)

A Colles' fracture is clearly seen on the 2D radiographs. Typical treatment would be cast immobilization or surgical fixation.

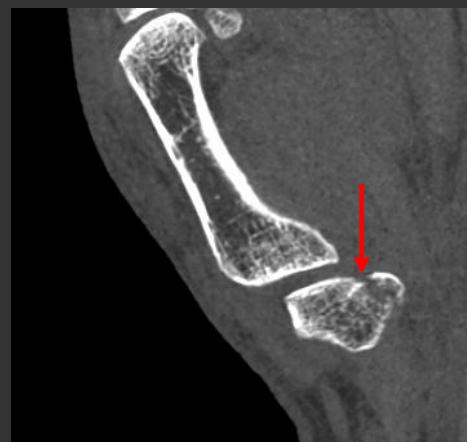
Figure 2 MPR slices from the patient in Figure 1 acquired with the OnSight extremity CT system showing a clear comminuted Colles' fracture of the distal radius with an associated fracture of the trapezium.

Diagnosis for this patient could potentially identify both the Colles' and trapezium fracture as it is easily seen in the extremity CT scan compared to 2D radiographs. Fractures of the trapezium are very important to detect and treat early given the importance of the trapezium in the carpometacarpal joint in actions such as grip and pinch<sup>1</sup>. Typical treatment could be cast immobilization or surgical fixation for both fractures in one treatment.

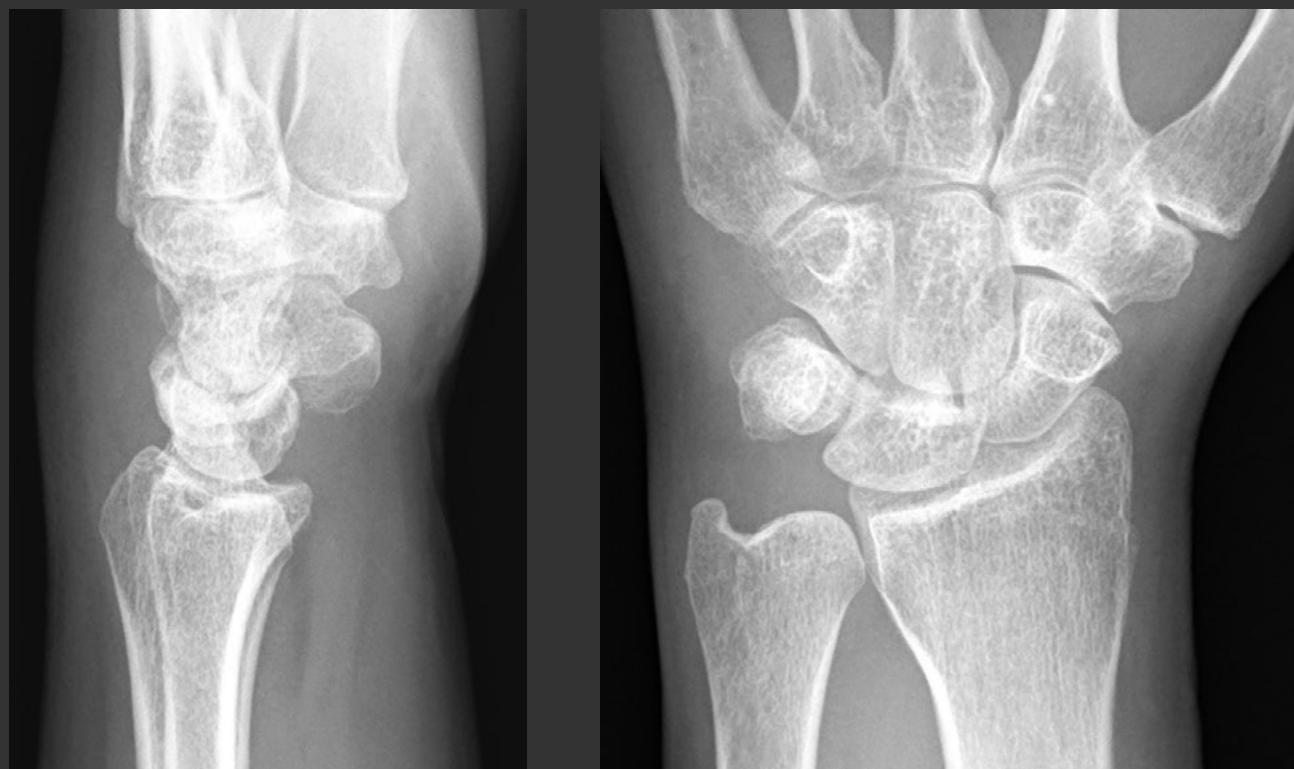
*Figure 1  
Standard 2D  
X-ray of  
wrist trauma  
patient with  
no obvious  
fracture  
seen.*

The traditional 2D projection X-rays (see Figure 1) did not show any evidence of a fracture but the patient was experiencing clear pain on the first row of the carpus (ulnar side).

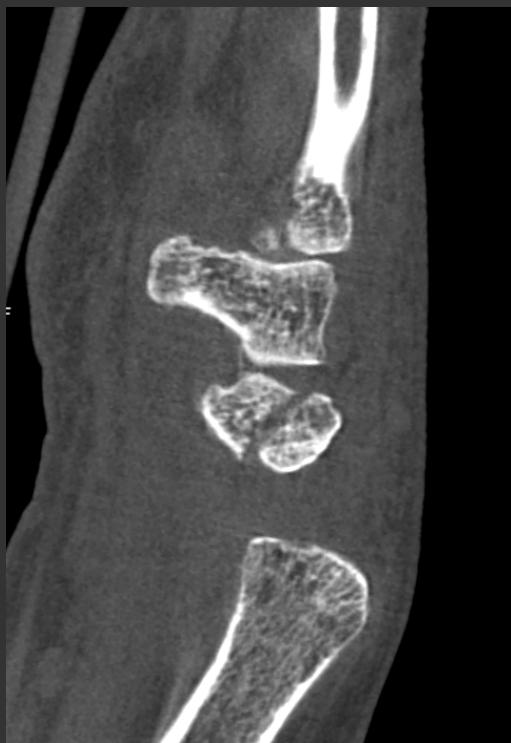
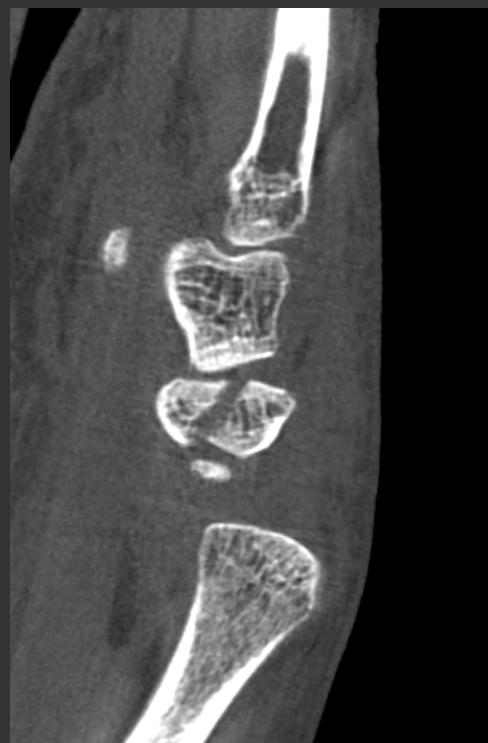
Figure 2 MPR slices from the patient in Figure 1 acquired with the OnSight extremity CT system identifying a clear fracture of the triquetrum not seen in Figure 1.

Figures 2 and 3 show various MPR slices from a 3D scan of the patient taken on the OnSight extremity CT, clearly indicating a large fracture of the triquetrum.

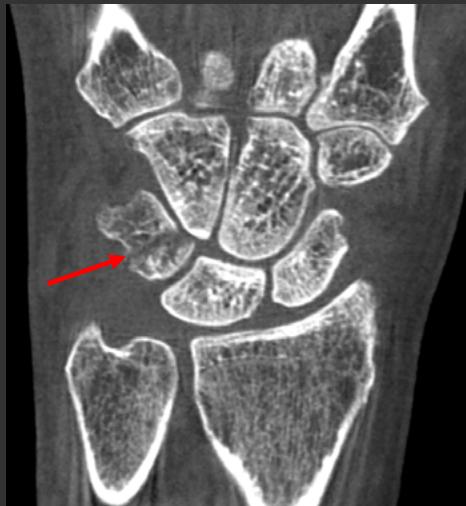
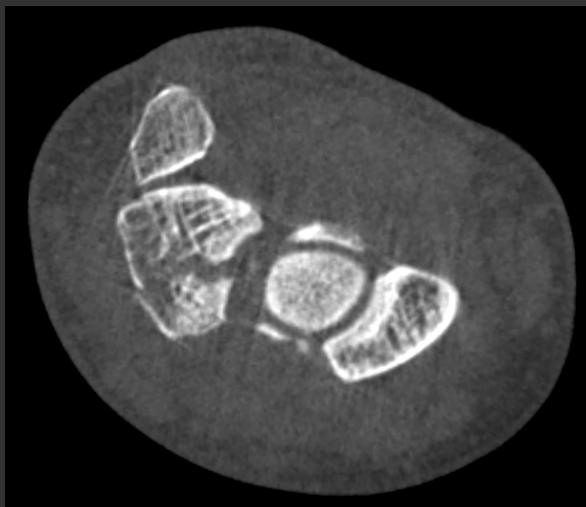
Figure 3 Coronal and axial views of the triquetrum fracture.

This important finding means the patient will be in a cast for a longer period of time than would have been indicated from the negative 2D X-rays. In addition, this type of injury can be a trigger factor for lunate dislocation and should be checked for consolidation and to ensure the fragments do not displace more with time. This example highlights the value of the inherently high image quality and 3D nature of the data provided by the OnSight extremity CT system.

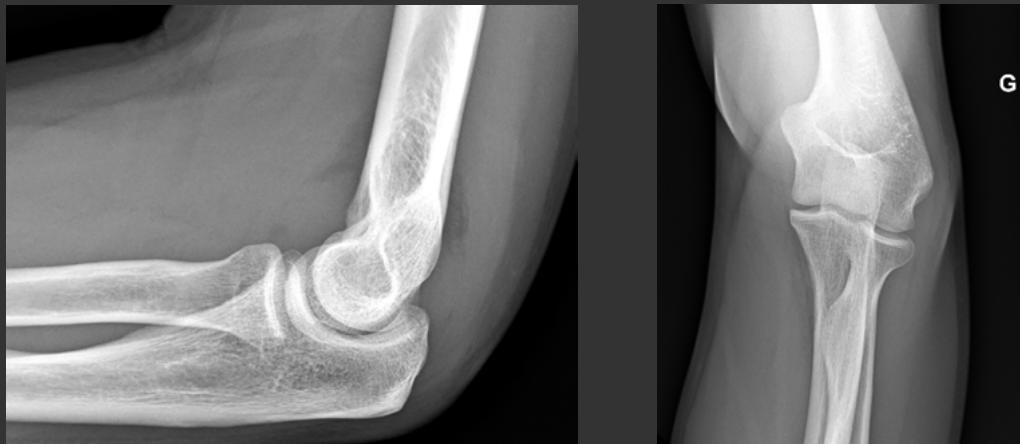
Figure 1 Standard 2D X-ray of elbow trauma patient with evidence of intra-articular fluid build-up consistent with a fracture, but no evidence of fracture seen.

The standard X-ray indicated significant intra-articular joint fluid consistent with a fracture, but no evidence of this was seen in either the AP or lateral X-rays that traditionally form the basis of the normal imaging workup for such a patient (see Figure 1).

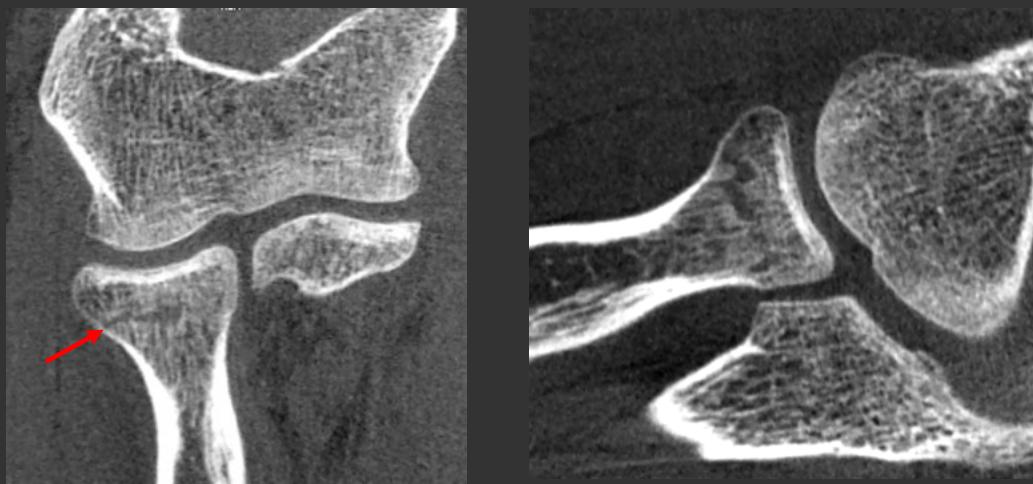
Figure 2 MPR slices from the patient in Figure 1 acquired with the OnSight extremity CT system showing a clear trabecular fracture of the radial head that was not visible on the standard 2D radiographs.

Evidence of a clear trabecular fracture of the radial head became apparent when the patient was scanned on the CARESTREAM OnSight 3D Extremity System. This is shown in Figure 2. The nature of the fracture, where most of the cortical bone was intact, meant that it was very difficult to appreciate on the 2D radiographs. This type of trauma required the patient to be placed in a cast rather than allowing elbow motion as might have been the diagnosis from the 2D radiograph. This case demonstrates the value of acquiring high-resolution 3D data for patients where fracture is suspected but not confirmed with traditional imaging protocols.

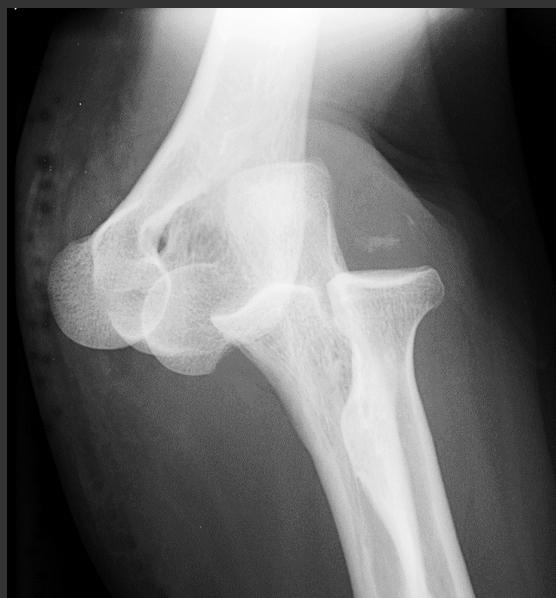
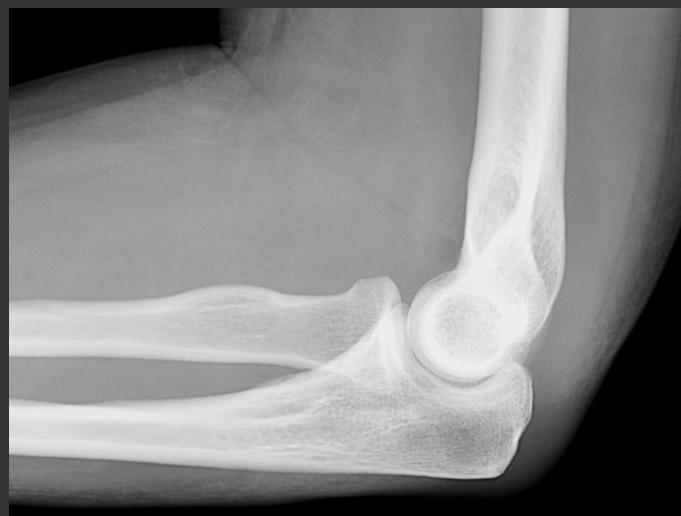
*Figure 1  
Standard 2D  
X-ray of elbow  
trauma patient  
with obvious  
dislocation pre-  
and post-  
reduction.*

The traditional X-ray shows obvious dislocation of the elbow. (See Figure 1 for pre- and post-reduction X-rays.)

With this type of trauma, the main concern for patient prognosis is for nervous and vascular lesions, and the dislocation should be reduced as quickly as possible. However, in addition to the dislocation, the 2D radiograph shows an additional bone fragment. The determination of the source of this fragment and whether there are any other consequences of the trauma is crucial in the successful reduction of the injury. It is not possible to identify the source of the fragment or to definitively rule out additional injury from the 2D radiographs.

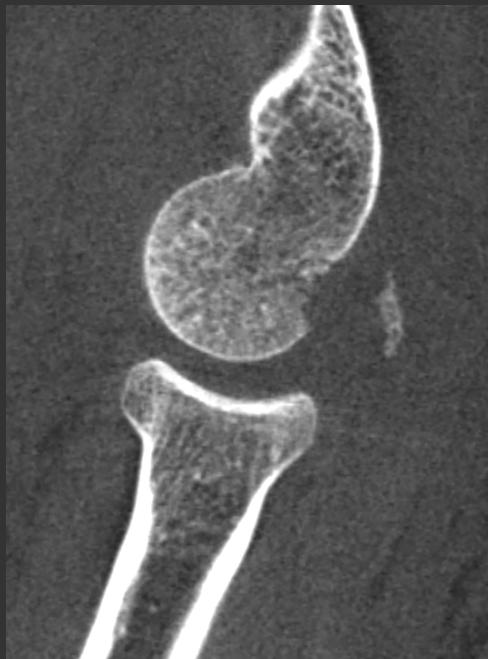
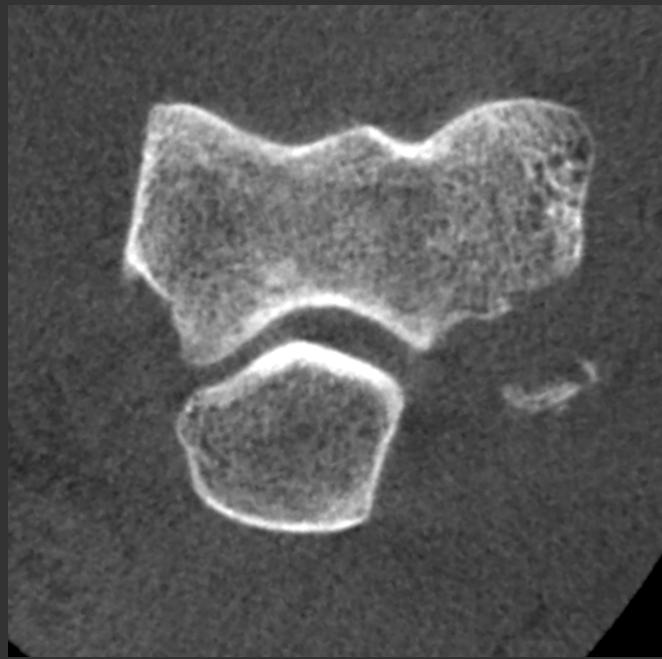
Figure 2 MPR slices from the patient in Figure 1, acquired with the OnSight extremity CT system, identifying the source of the bone fragment seen in the 2D radiographs as a lateral epicondyle avulsion.

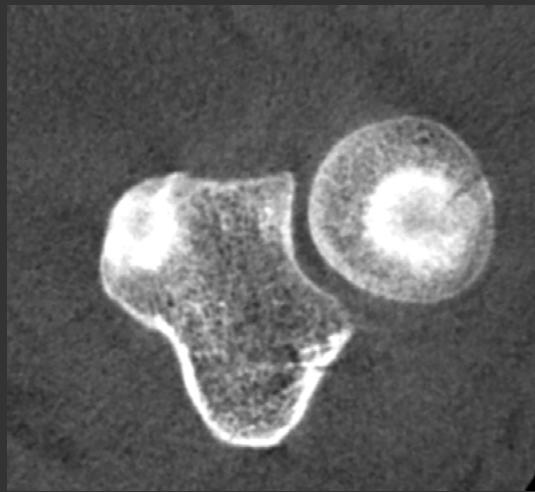
Figure 3 Evidence of a small radial head fracture probably caused by impaction during the dislocation injury not readily appreciated on the 2D radiographs of this patient.

In addition to this diagnosis, further inspection of the 3D data set revealed a small un-displaced radial head fracture resulting from impaction during the dislocation (see Figure 3). This injury would be impossible to identify on the traditional 2D radiographs.

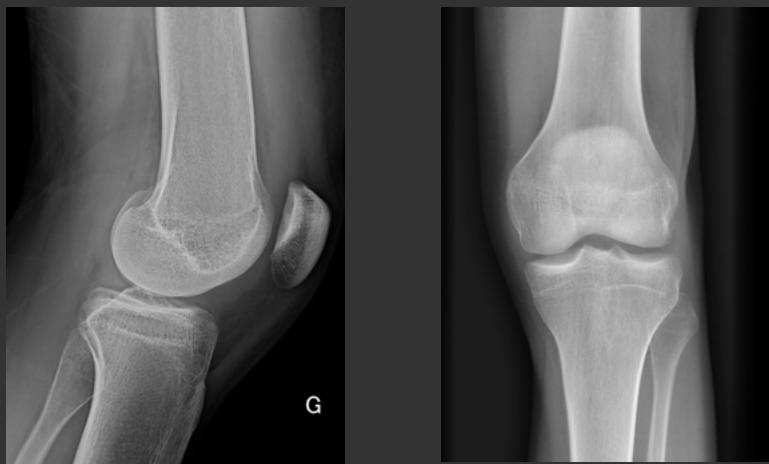
Figure 1 Standard 2D X-ray of knee trauma patient. Evidence of intra-articular fluid, but with no obvious fracture seen.

The traditional 2D projection X-rays (see Figure 1) show no clear evidence of fracture but did show intra-articular fluid. Patient was unable to walk, which is not typically consistent with ligament/soft tissue damage and a tibial plateau fracture was suspected. Normal protocol would be for the patient to be given an MRI at 2-3 weeks post injury.

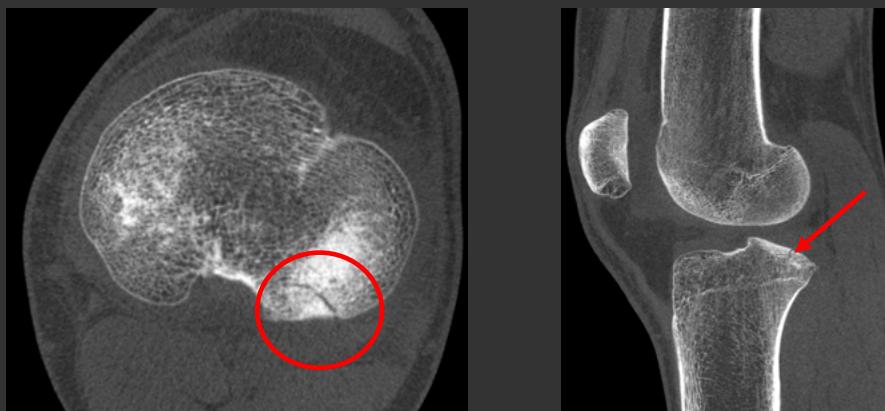
Figure 2 Axial and sagittal slices from the patient acquired with the OnSight extremity CT system identifying a clear impaction fracture of the lateral aspect of the posterior tibial plateau not seen in Figure 1.

Figure 2 shows an axial and sagittal slice from the patient's CARESTREAM OnSight 3D Extremity System scan that shows a classic impaction fracture of the posterior aspect of the lateral tibial plateau missed on the 2D X-rays.

It is important that this type of fracture is identified and addressed since it can lead to osteoarthritis if left untreated. It also helps to determine the length of time the patient should be in a cast. This example highlights the value of the inherently high image quality and 3D nature of the data provided by the OnSight extremity CT system.

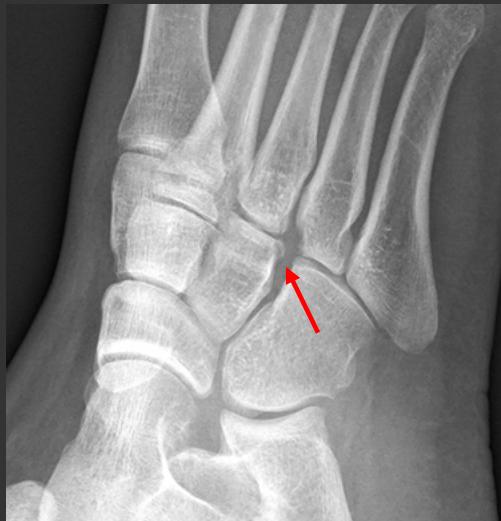
Figure 1 Standard 2D X-ray of foot trauma patient showing small fractures on the lateral side of the lateral cuneiform and the lateral aspect of the proximal epiphysis of the third metatarsal, indicative of a possible Lisfranc injury.

The traditional 2D projection X-rays (see Figure 1) shows evidence of a small fracture on the lateral side of the lateral cuneiform bone and the lateral aspect of the proximal epiphysis of the third metatarsal. This presentation is indicative of a Lisfranc injury and there is a need for a precise lesion assessment to uncover additional injuries and ensure proper treatment for the patient. Failure to identify all aspects of this type of injury can have significant negative impact on the prognosis for full recovery. Historically, 2D imaging is known to miss a significant number of aspects of Lisfranc injury, with clinicians relying heavily on identifying pain during physical exam as a final arbiter of the full scope of the injury.

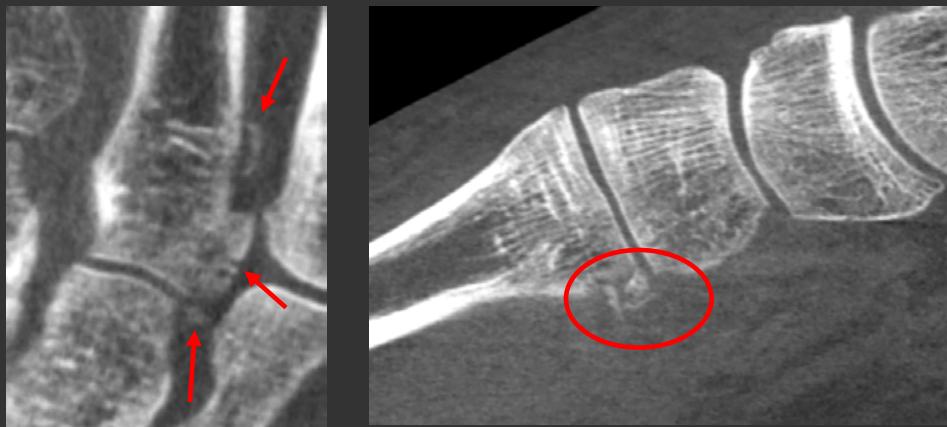
Figure 2 MPR slices from the patient acquired with the OnSight extremity CT system identifying multiple fractures of the base of the second metatarsal not seen in Figure 1.

Imaging with the CARESTREAM OnSight 3D Extremity System showed a number of further injuries. Figure 2 shows multiple fractures of the base of the second metatarsal:

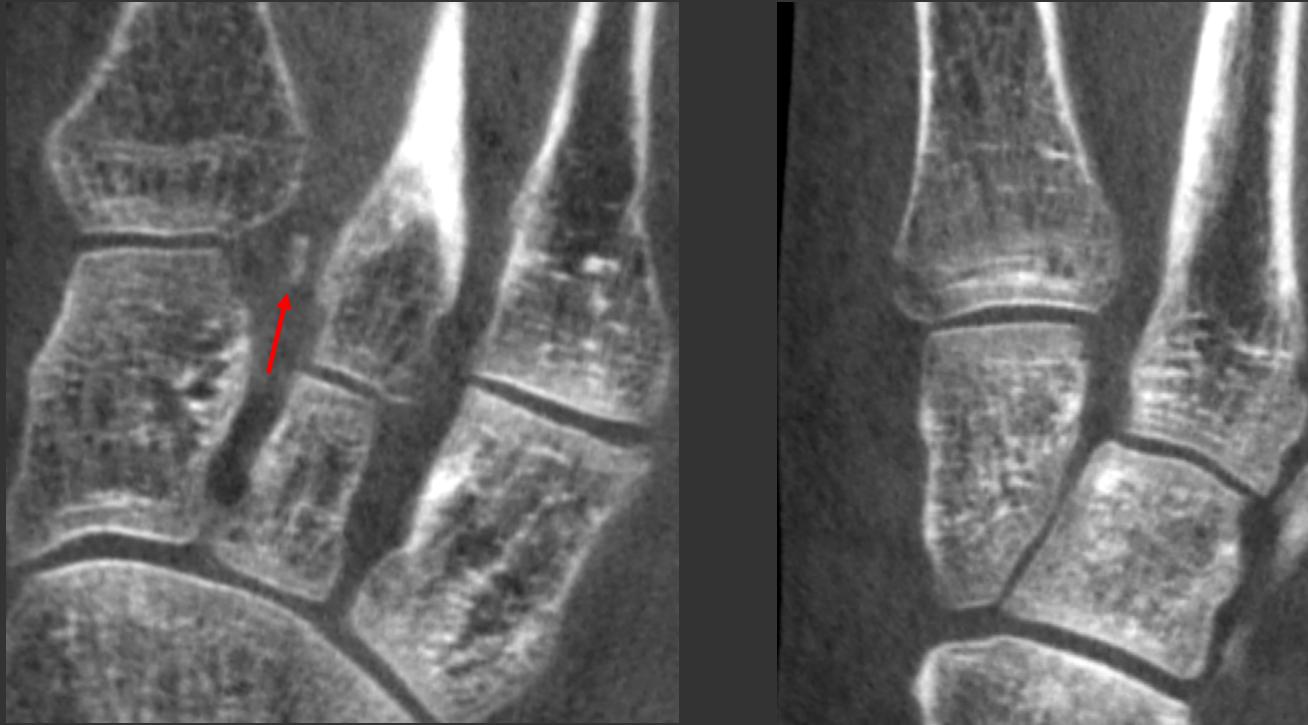
Figure 3 shows evidence of another evulsion fracture of the lateral side of the medial cuneiform bone as well as a fracture of the base of the first metatarsal bone, both unappreciated in Figure 1:

These additional injuries are important to identify and indicate that this patient will require a cast for a significant length of time.
